Perfecting PFOA-free PTFE Coating Adhesion on Stainless Guidewires

New process provides PTFE adhesion after soaking in saline solutions

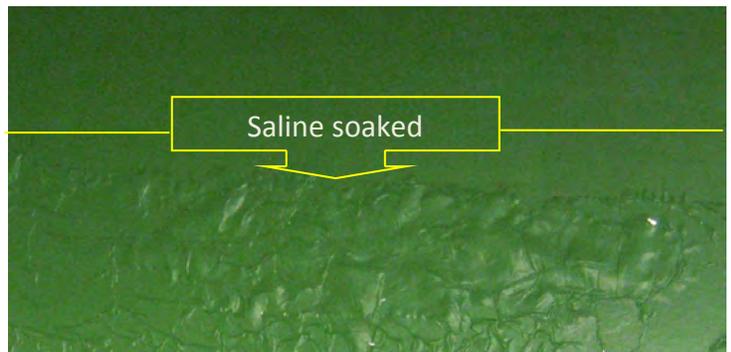
What appears to be a smooth, bonded no-PFOA PTFE coating on this panel, once immersed in saline for 30 minutes at 80 Fahrenheit, starts to delaminate otherwise stainless steel panel.

Most aqueous PFOA-free PTFE coatings appear to be particularly sensitive to these phenomena. When immersed in even mild saline solutions—similar to those found in surgeries (0.5-0.9%) or body fluids—the coatings tend to blister, wrinkle, and peel off.

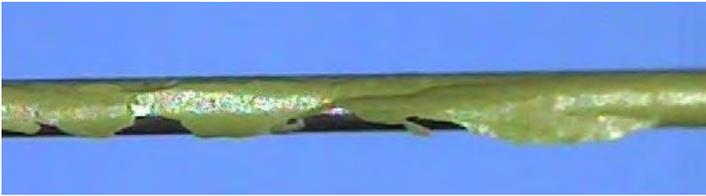
Saline Soak Test Results (.012" dia. 304v wire)

Loss of PFOA-free PTFE adhesion on guidewire after being soaked in a 0.9% saline solution at 80°F for 30 minutes.

Post-cure testing takes coating adhesion testing to a new level. First, samples of coated wire are immersed in a 0.9% saline solution and held consistently at 80° F for 30 minutes. Since this is at the upper limit of surgical saline it is considered a worst-case scenario for the coating.

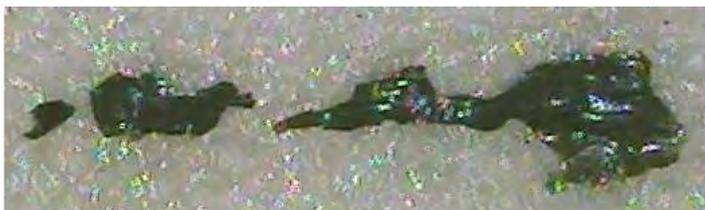
Using the high-tack tape employed in the FluoroBond® process, flakes of commercially available PFOA-free PTFE coating are pulled off easily from a guidewire that has not been treated with the FluoroBond® process. (100 X)

— subjected to a tape-pull adhesion test that is beyond conventional practices. Normal ISO 2409 or ASTM 3349-02 test tapes have an adhesive strength of .22875 LBF/in. SSG now uses tapes with 3 times the adhesive strength. Both tapes have excellent adhesion to PTFE surfaces.
